Minerals Inspection Report

Report Date: 12/08/2014

Mine Name: Black Knight	Permit Number: S/015/0078	Mine Status: Active
Operator Name: Goldterra Inc.	Inspection Date: 12/08/2014	Permit Fees: Paid
Inspector(s): Wayne Western	Inspection Time: 10:40 - 11:00 am	Bond Amount: \$7,600
Attendee(s):	Weather:	Bond Escalation: 03/02/2014
Inspection Purpose: Routine inspection		Prior Inspection: 10/30/2014

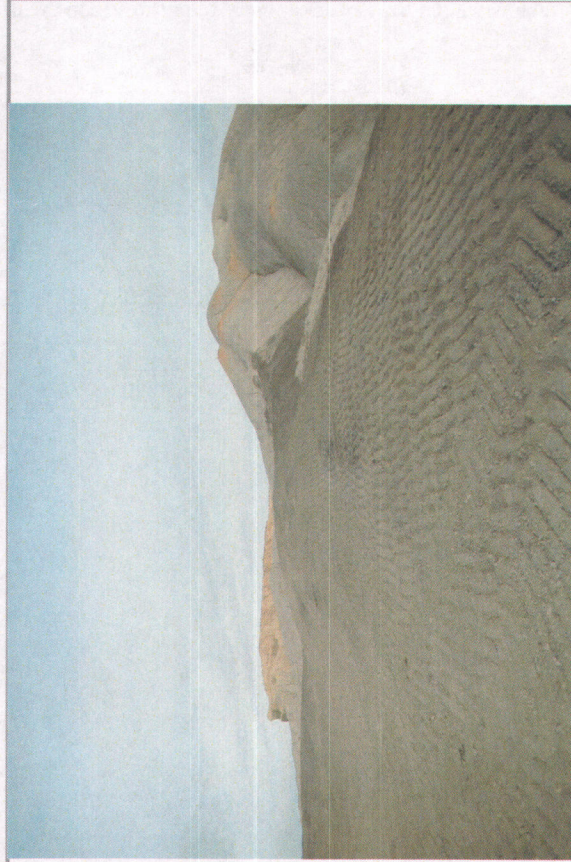
Reclaimed area looking north. Area was blended into the surrounding areas.

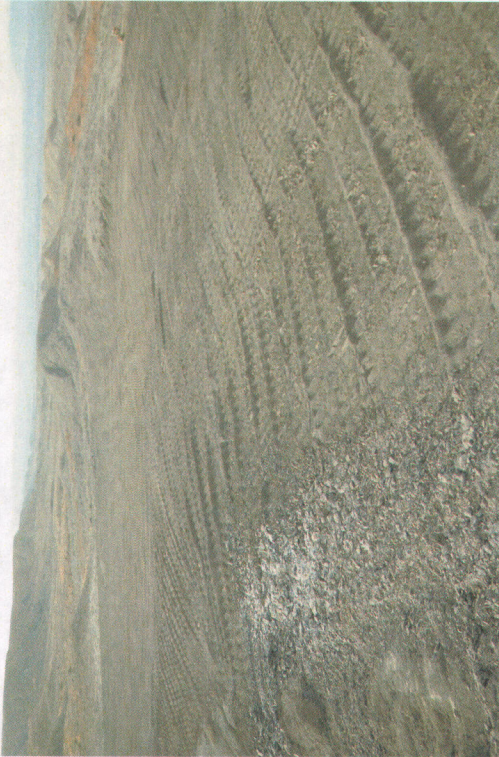
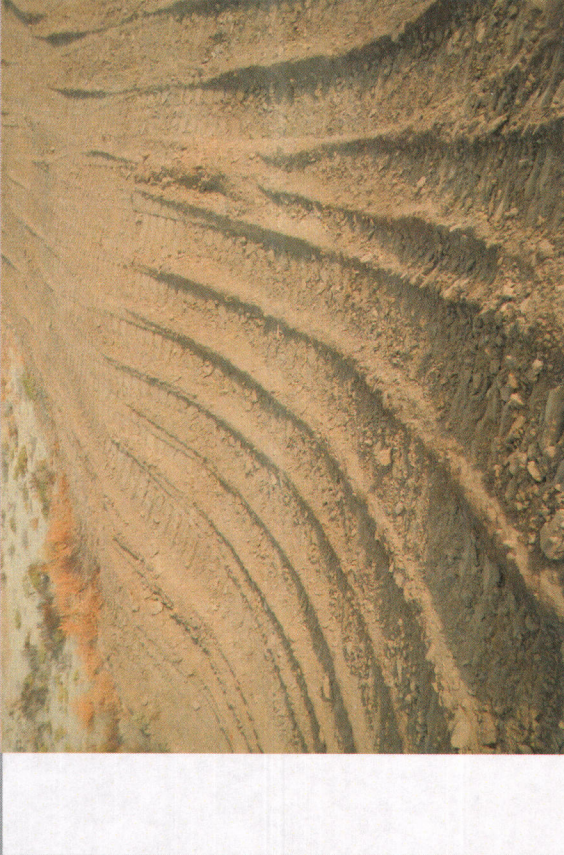
<p>Pit has been filled in and surface roughened.</p>	<p>Access road looking east. Tracks used to prepare ground for seeding.</p>

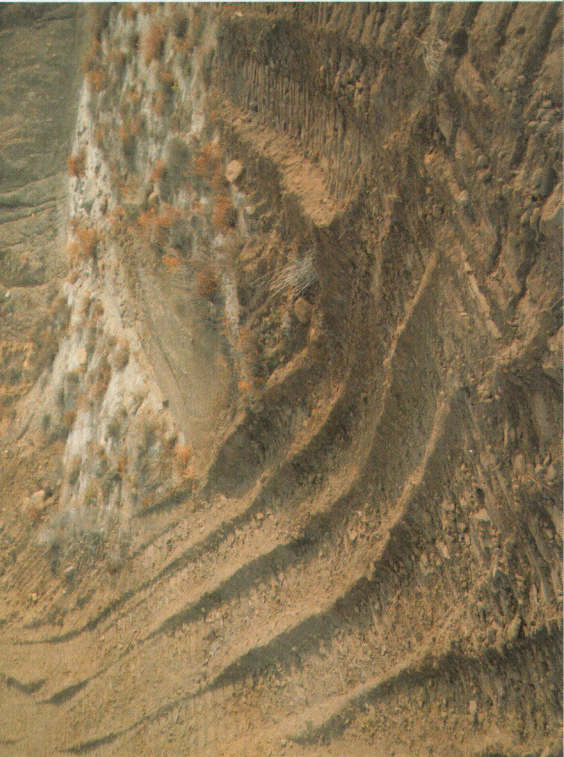
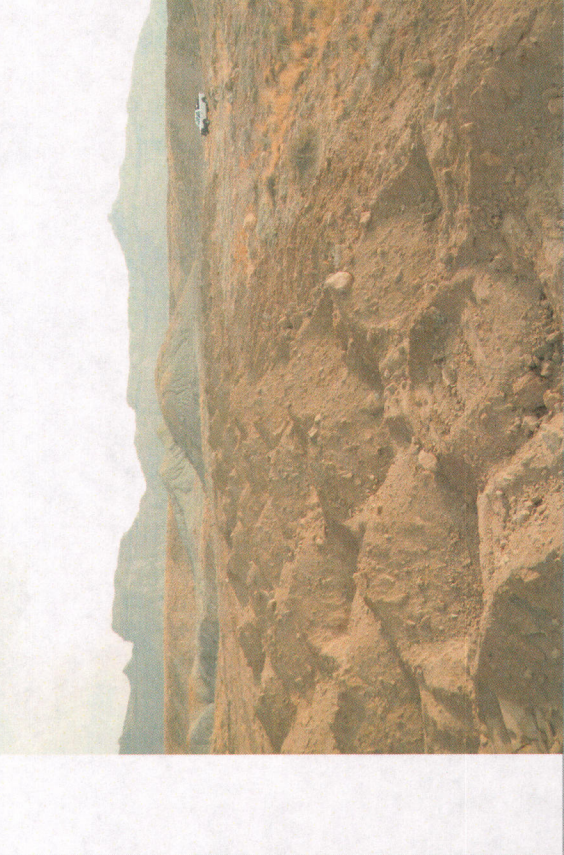
<p>The contractor had to do some earthwork on the access road along the gully. The contractor used tracks to create pocks for seeds and moisture to collect.</p>	<p>Parts of the road were pocked.</p>
